Active Errata List

CAN Microcontrollers

T89C51CC02

Errata Sheet

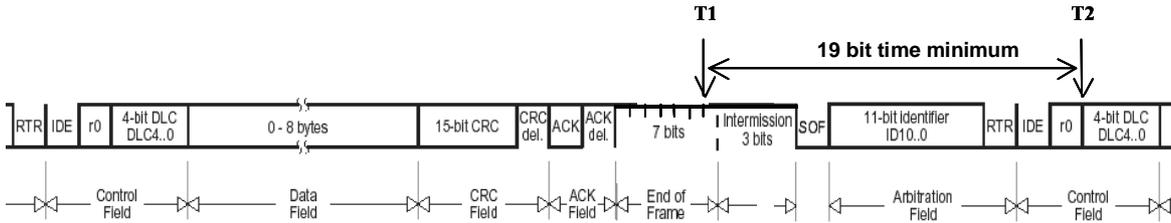
Always have a Receive MOB enabled ready to accept any incoming messages. Thanks to the implementation of the CAN interface, a Receive MOB must be enable at latest, before the 1st bit of the DLC field. The Receive MOB status register is written (RXOK if message OK) immediately after the 6th-bit of the End Of Frame Field. This will leave in CAN2.0A mode a minimum 19-bit time delay to respond to the end of message interrupt (RXOK) and re-enable the Receive MOB before the start of the DLC field of the next incoming message. This minimum delay will be 39-bit time in CAN2.0B. See CAN2.0A CAN2.0B frame timings below.

The workaround is to have the last MOB (MOB3) as "spy" enabled all the time; it is the MOB of lowest priority : If a Mob other than MOB3 is programmed in receive mode and its acceptance filter matches with the incoming message ID, this Mob will take the message. MOB3 will only take messages than no other MOBs will have accepted. MOB3 will need to be re-enabled fast enough to manage back to back frames. The deadline to do this is the beginning of DLC slot of incoming frames as explained above.
